## Is the Nemasket River Stressed Out?

Apponequet Regional High School, Lakeville, Massachusetts (2007). *Is the Nemasket River Stressed Out?*. In Watershed Access Lab Projects. Project 59.  
Available at: [http://vc.bridgew.edu/wal\\_projects/59](http://vc.bridgew.edu/wal_projects/59)

# Introduction to the Nemasket River

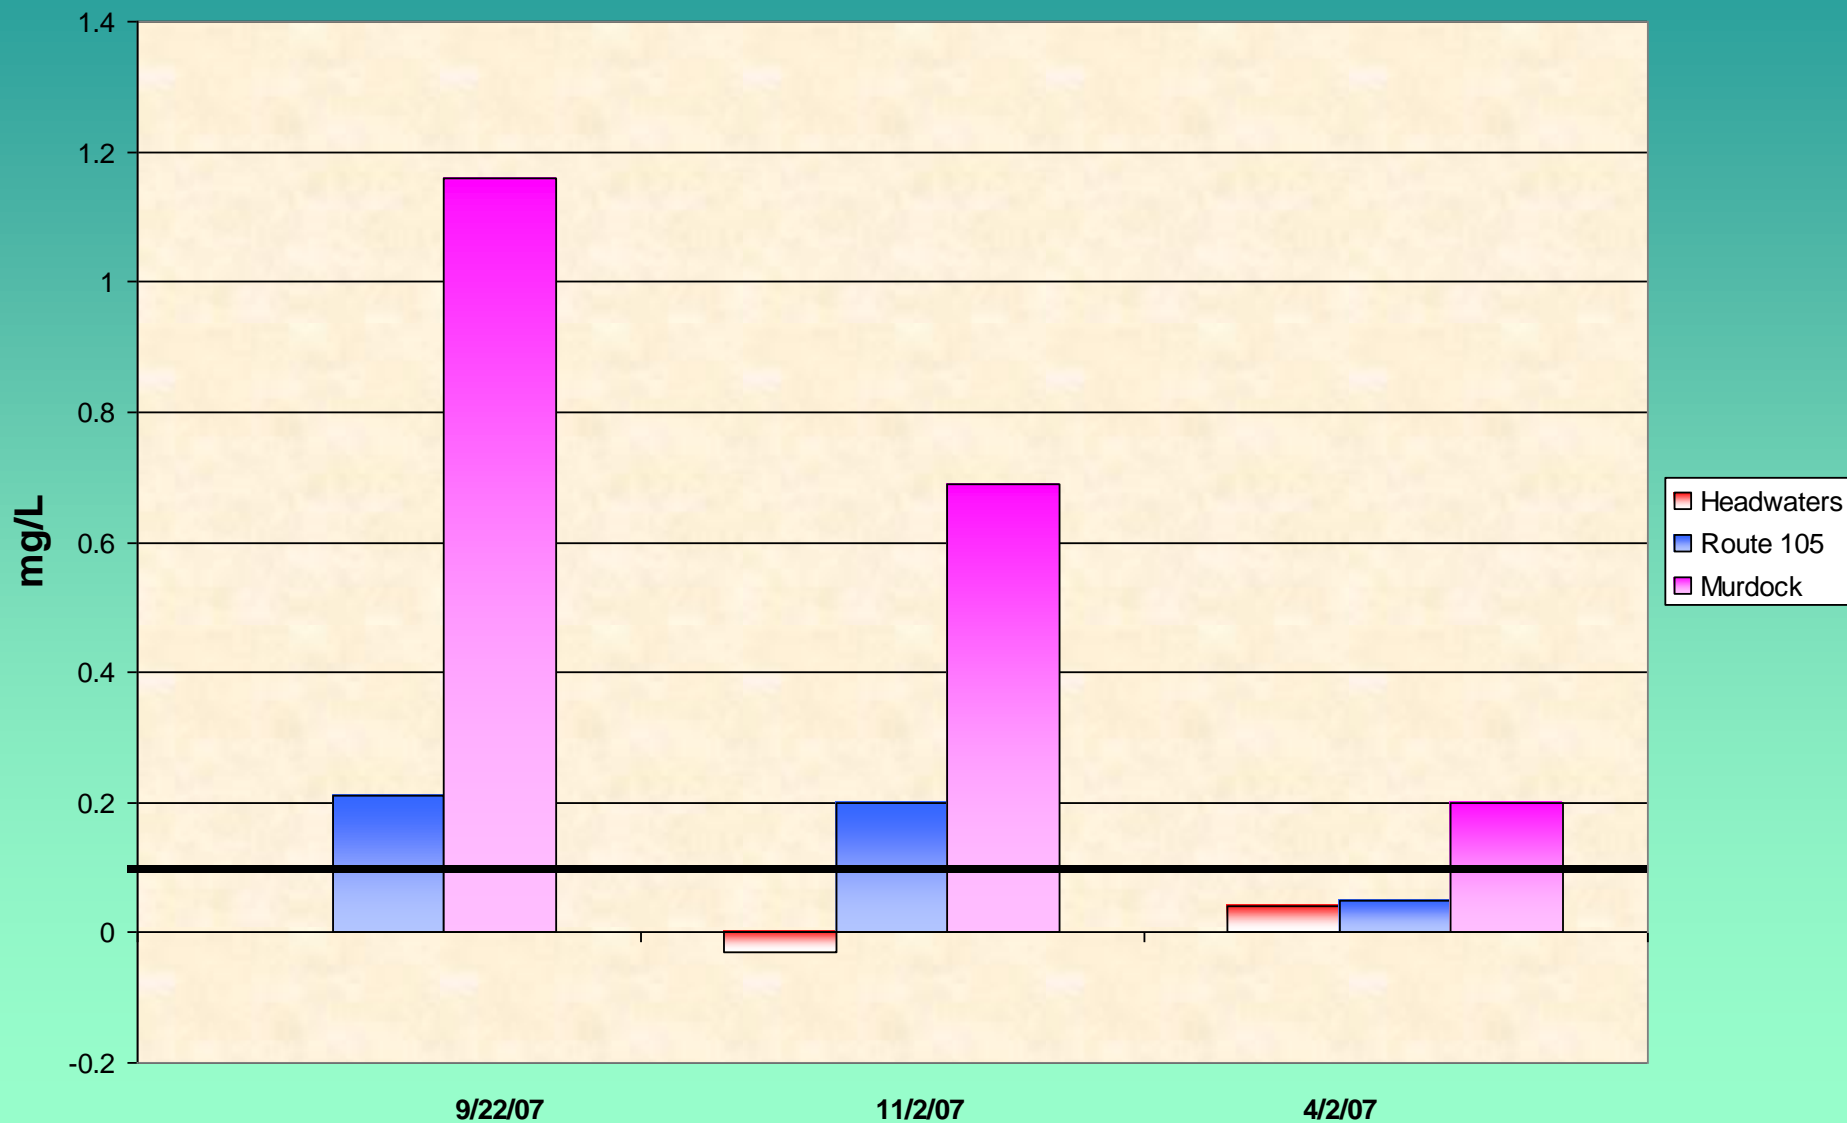
## Concentration of Nitrogen, Nemasket River, 2006-2007

- Our hypothesis has been proven correct.
- Nutrient Loads are higher at Murdock Street than the other two sites.
- Our conclusion is that the Middleboro Wastewater Treatment Plant causes stress to the Nemasket River.
- The water quality of Route 105 is excellent, and the water quality of Murdock is fair based on the Family Biotic Index.

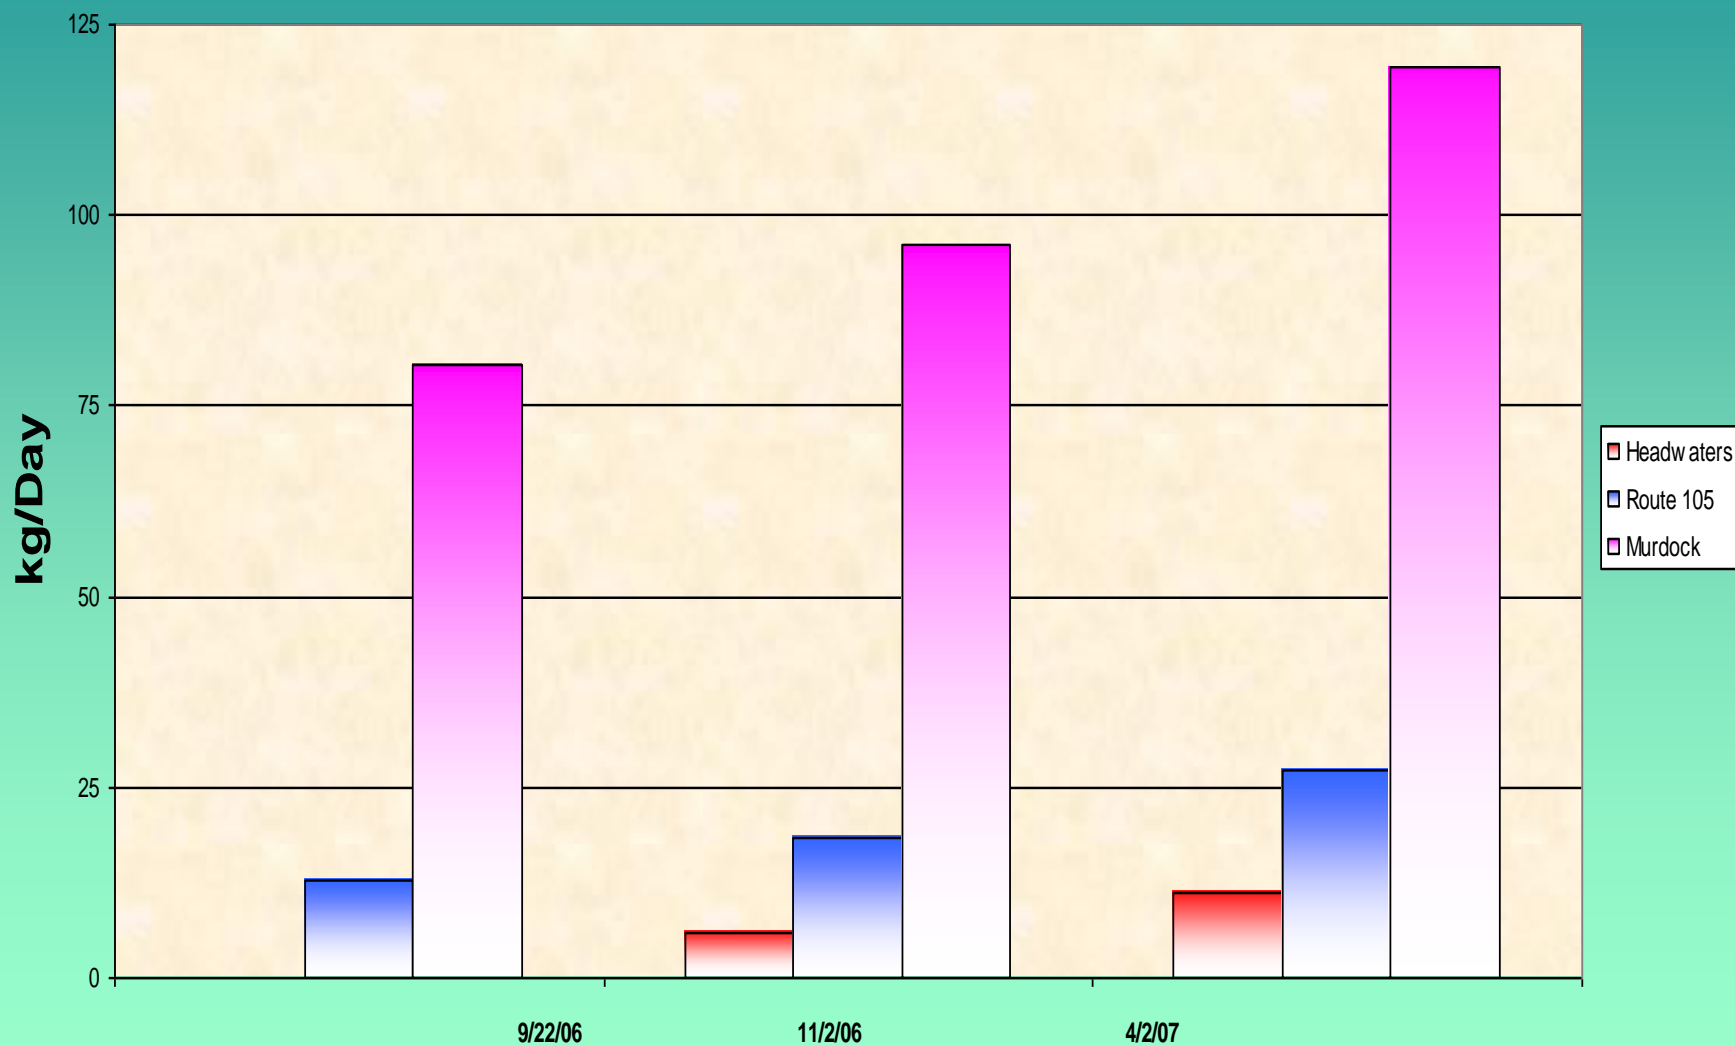
# Load for Nitrogen, Nemasket River, 2006-2007

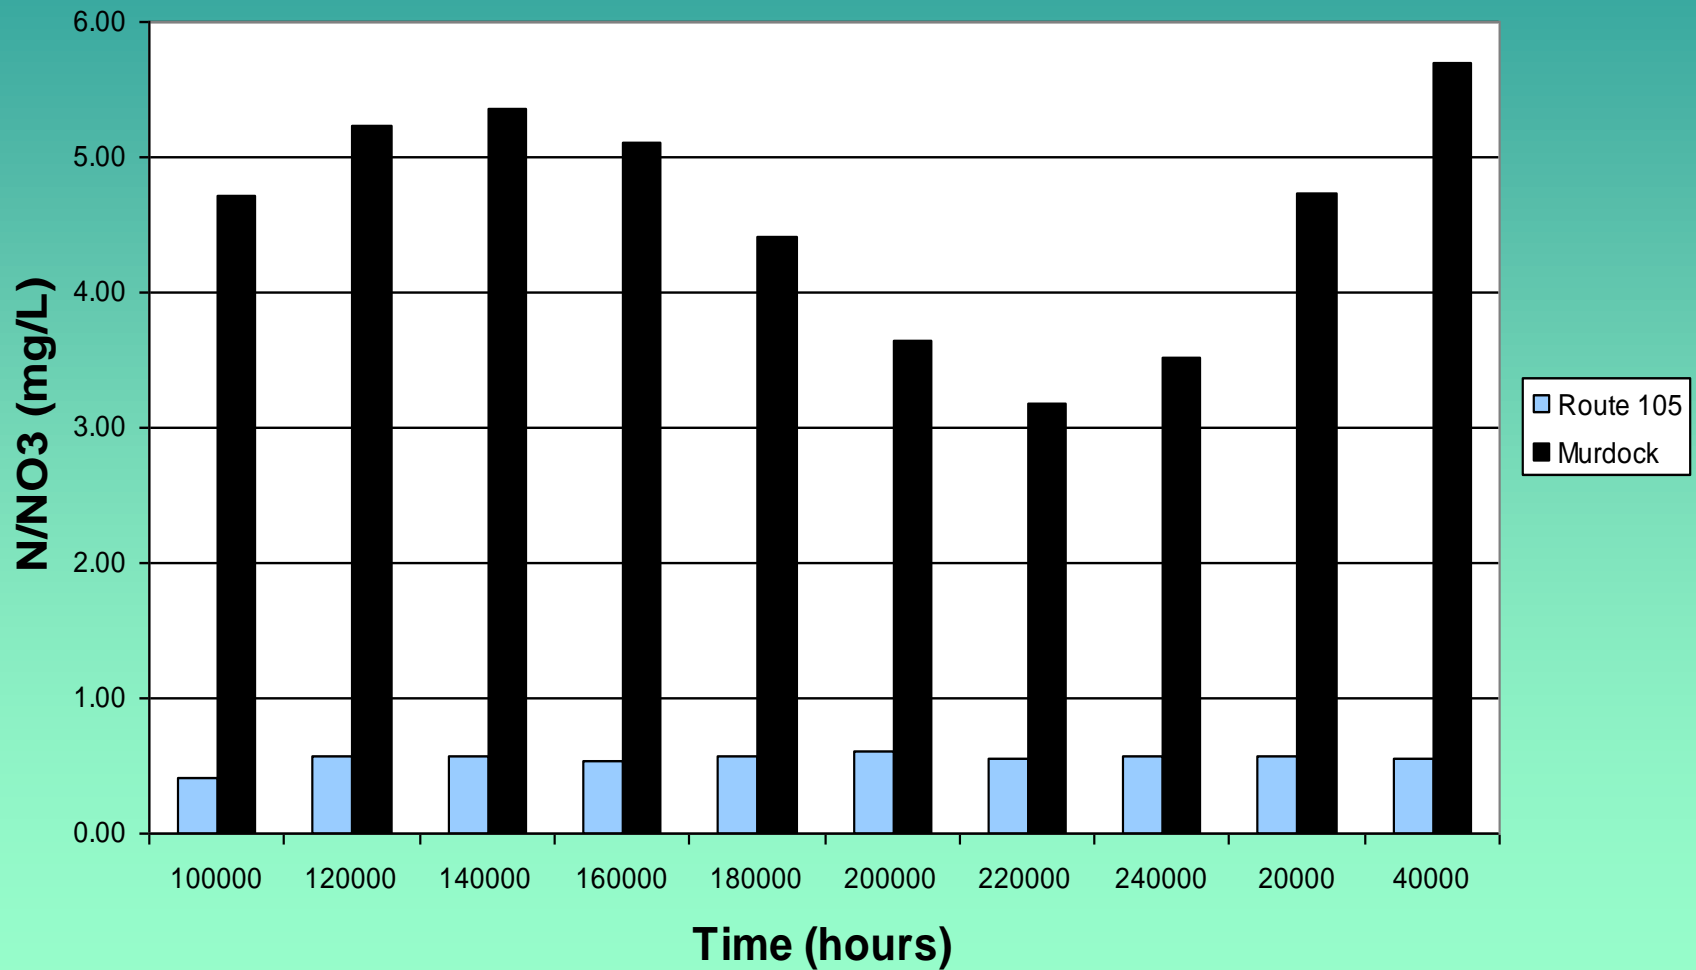
# Comparison of Nitrogen/Nitrate for Nemasket River, Route 105 and Murdock Street August 17-18, 2005
